King County's efforts to properly maintain the South Park Bridge and keep the bascule spans operational have resulted in numerous bridge inspections and engineering studies. Since 1990, over 30 studies have been conducted that evaluated the soils, analyzed deficiencies, assessed load carrying capacities, and endeavored to determine its remaining life. The objective of this technical memorandum is to provide the County with a single document that contains a peer review of relevant studies, compares the South Park Bridge with similar bridges in the Seattle area, identifies risk factors for the existing bridge, and offers recommendations for next steps.

1.2 PEER REVIEW

The reports reviewed for this memorandum, all conclude the South Park Bridge is in need of major rehabilitation or replacement. While these conclusions are similar, the approach and methodologies which led to these conclusions varied amongst the documents reviewed, due to the complexity and uncertainties associated with the bridge structure.

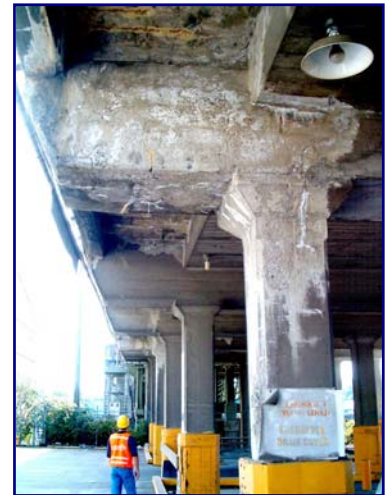
A representative core was prepared and tested in accordance with ASTM C856, *Petrographic Examination of Hardened Concrete*. The petrographic analysis results showed evidence of the effects of alkali silica reactions (ASR). This is a condition where silica present in certain aggregates, either rocks or sand, combines with water to form a gel that absorbs water and expands, potentially damaging the concrete.

For reinforced concrete bridges, one of the major forms of environmental attack is chloride ingress, which leads to corrosion of the reinforcing steel and subsequent reduction in the strength, serviceability, and aesthetics of the structure. Test results of the approaches showed levels of water-soluble chloride ions ranging from 306 to 610 parts per million. It was noted in the reports that FHWA guidelines consider levels higher than 500 parts per million sufficient reason to replace a deck slab. Although the concrete may be able to continue supporting the structure, the levels of deterioration are such that it is unreasonable to continue repairing the concrete and it is time to plan for replacement.

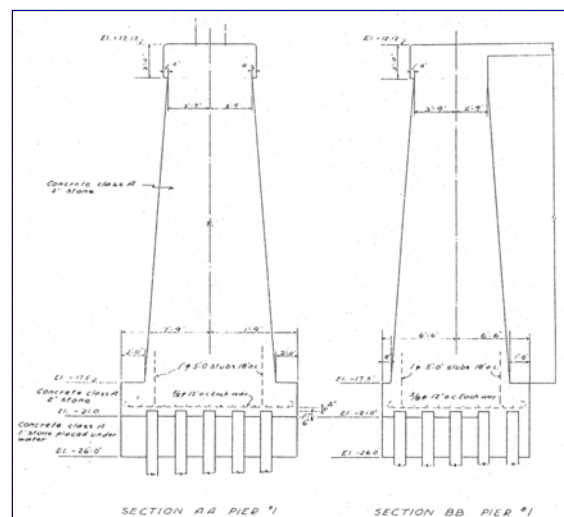
The soil conditions in the vicinity of the steel truss approach foundations are the same that exist throughout the project site. There is a potential for liquefiable soils in the upper 40-foot layer. This condition could lead to lateral spreading of up to 30 feet and vertical settlements up to 2 feet during a major seismic event.

Condition of the concrete piers has been rated as fair. Hairline and map cracking is prevalent on all exposed faces. Deterioration and softening of concrete has been encountered on the top of footings and several corners have spalled. Repairs have had mixed success, with some repairs intact and others delaminating.

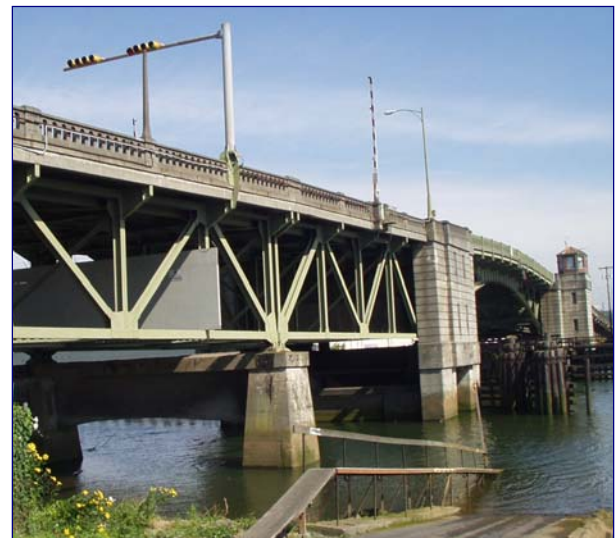
All primary structural elements are considered sound. The common concern throughout the reports is the

inadequate restraint and the absence of a complete lateral load path to transfer seismic loads from the deck level to the supports. Report No. 11 concludes that the vertical truss members will be severely damaged in a minor seismic event, may collapse during a moderate seismic event, and will collapse during a major seismic event. Had the Nisqually earthquake lasted longer, this may have occurred. This is an important issue, because if the bridge were designed to current standards, it should not only survive the moderate seismic event without collapse but should not collapse under a major seismic event.

In the interim, the trusses should be load tested along with the concrete approaches. It is also recommended that work be done to provide a minimum level of protection from collapse. Full seismic retrofitting is not economically reasonable, but structural strengthening to prevent collapse during at least a moderate seismic event is recommended. This would include strengthening vertical truss members that are susceptible to collapse during a moderate earthquake.
